DESERT STATE HOME INSPECTIONS
5425 E Pershing Ave.
Scottsdale AZ 85254
(480) 585-6456
www.desertstateinspections.com

Inspection Summary

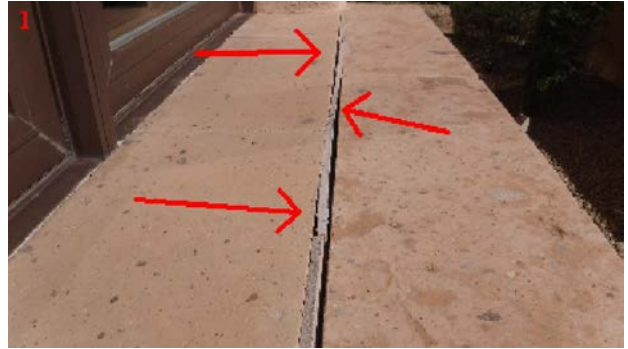
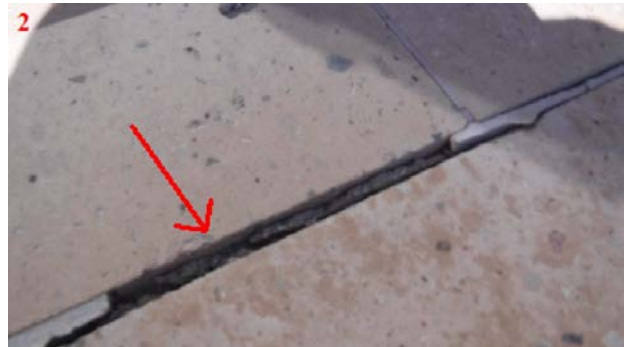
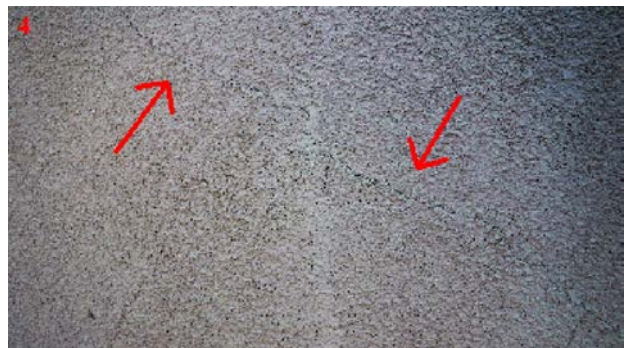
Service/Repair **Cladding - Stucco**

Stone ledge outside kitchen window, grout cracks noted. Recommend sealing to prevent moisture intrusion and further damage.

Stucco cracking along North balcony stairway. Runs parallel with stairway. Recommend repair. Previous repairs were noted.

Typical cracks. Standard for stucco repair is width of dime-recommend monitoring.

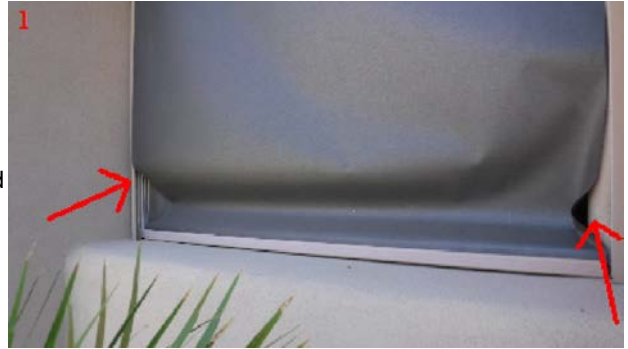
Service/Repair Window Screens - Missing

Middle exterior window shade outside living room bunches up when closed. Recommend adjustment.
Kitchen Windows are missing screens. Few screens noted in garage.
NE window at laundry has missing screen. Use Caution when opening blind. It is held in place by magnets, not hinges.
Standard for window screens is every window that opens is required to have screen.

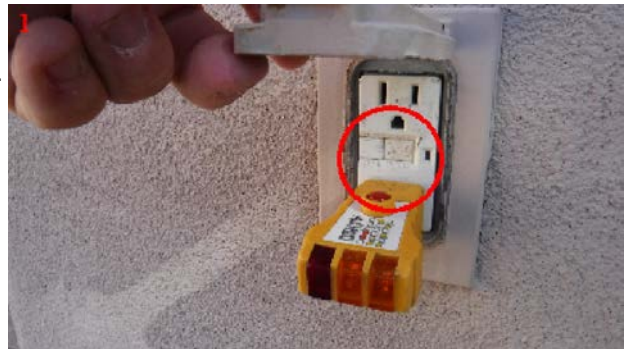
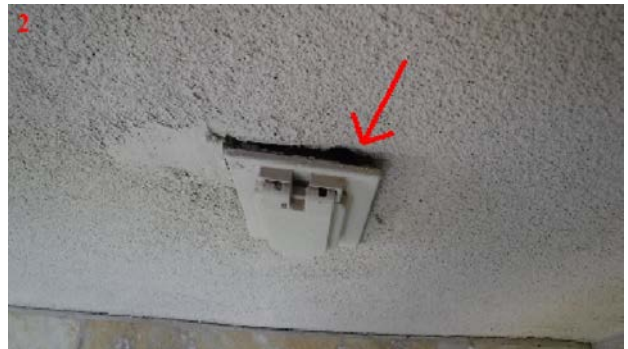
Safety Concern Outlets - GFCI, Grounded

SE outlet by garage door, GFCI outlet would not trip as designed. Recommend replacing outlet.
SW patio outlet cover is not secured properly, open conditions exist. Recommend repair.

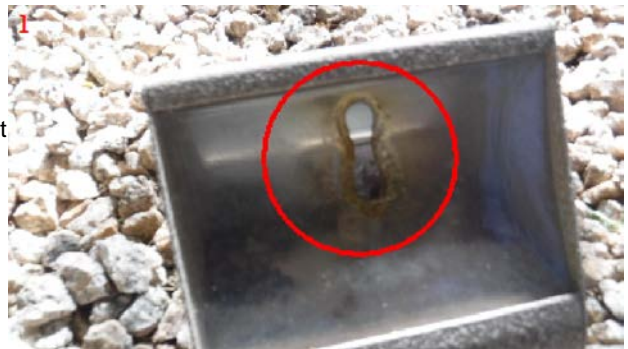
Service/Repair Lighting - Needs Repair

Few bulbs appear to have burnt out on exterior of home and should be replaced.
Although low voltage lighting is outside the scope of the home inspection process, a light along the West side of the yard had a melted cover and should be repaired. Would not expect bulb to melt cover, potential too large of bulb installed.

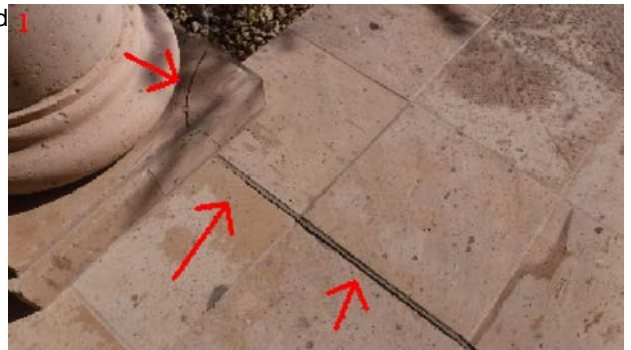
Entry - Tile

Evidence of heaving visible at entry walkway, slight deflection noted and bottom of column has cracked. Recommend monitoring. Columns are stone.

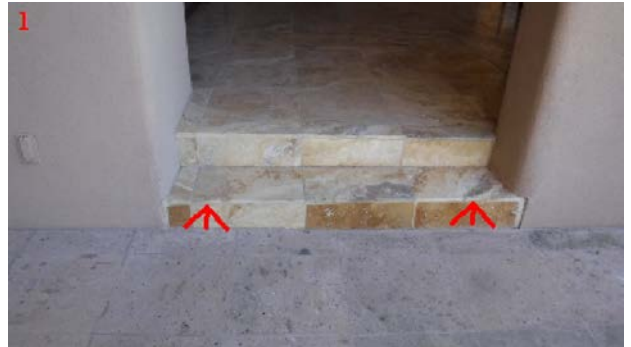
Steps - Tile

Step treads and risers should all be the same height and width. A trip hazard exists if a difference of 3/8" is present. Example West patio by BBQ.

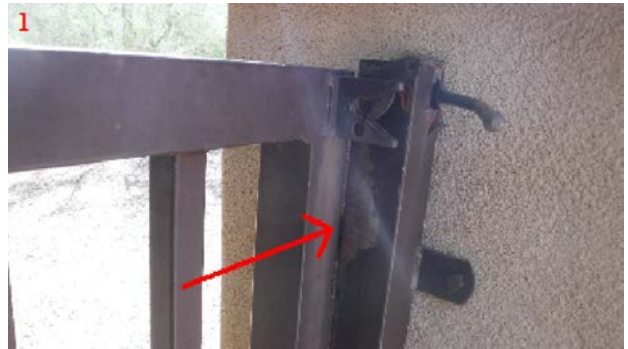
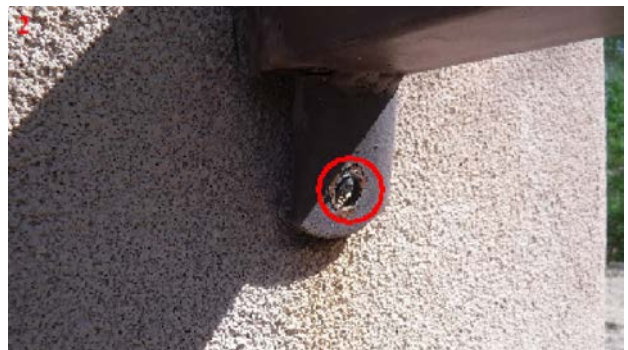
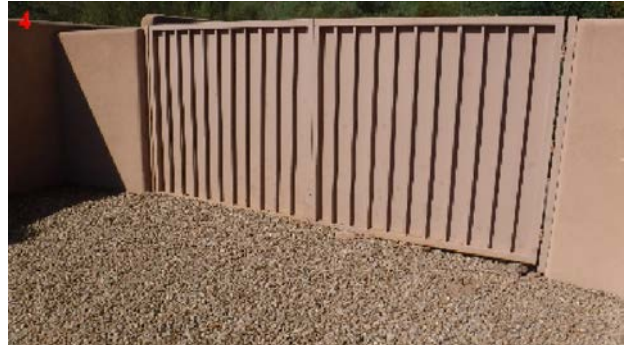
North metal fence is loose at column. Anchor head is missing.

Vehicle access gate has soil and rock up against it, unable to test.

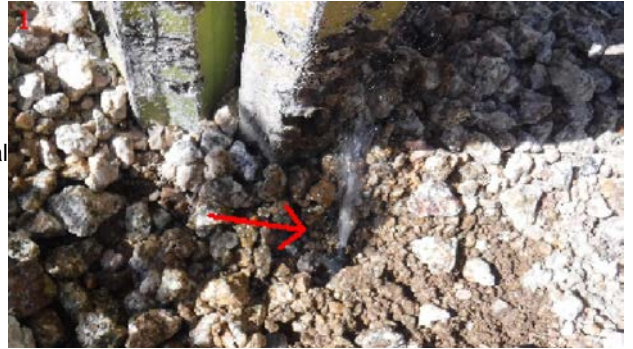
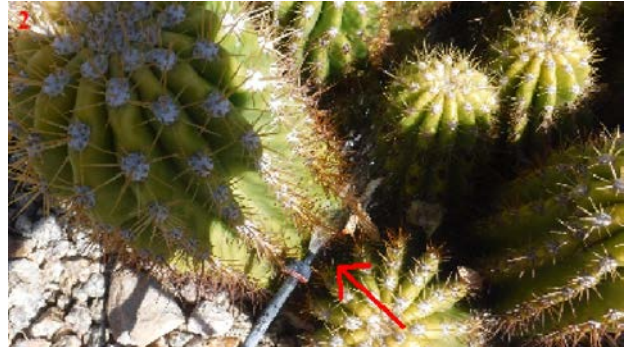
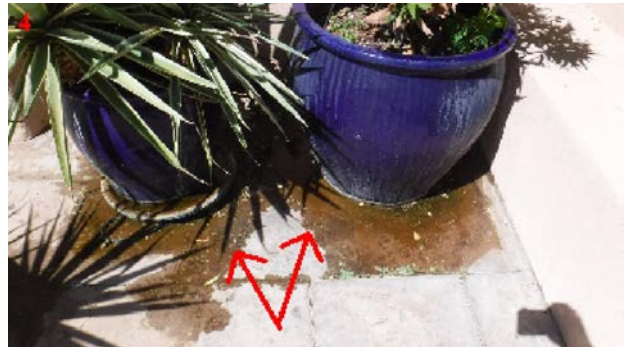
Service/Repair Irrigation - Needs Repair

At least 2 drip heads were not operating as designed at time of inspection, water was spraying out and not dripping as intended. Water around base of a few planters, evidence of leaking or overwatering.

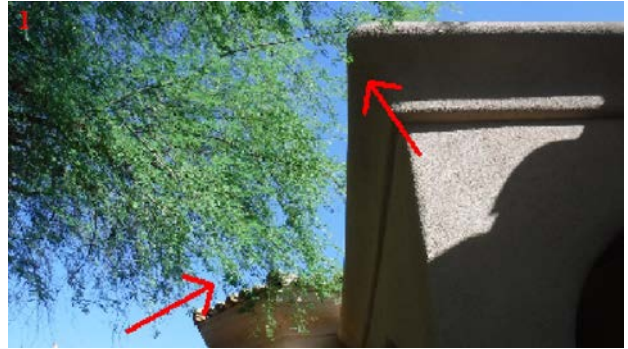
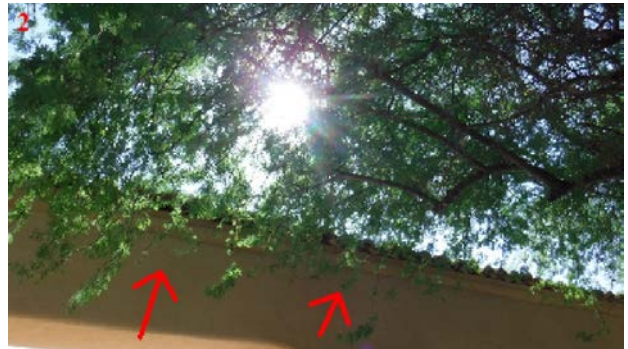
Service/Repair **Vegetation - Needs Trimming**

Recommend keeping trees cut back from roof line- can cause roof tile damage.

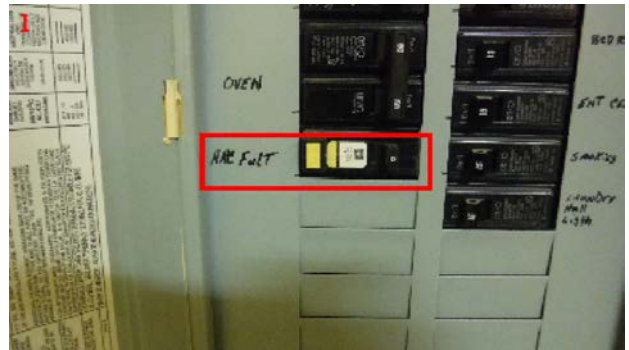
Arc fault breaker in sub panel B did not trip when tested and should be replaced.

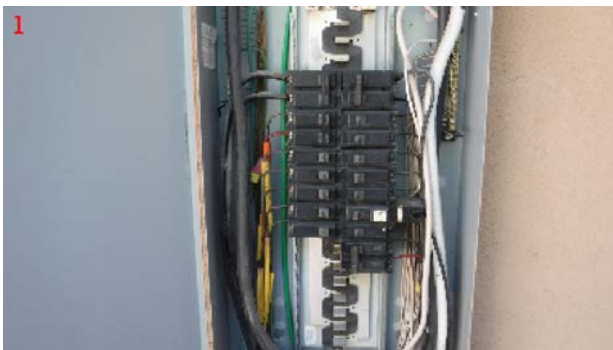
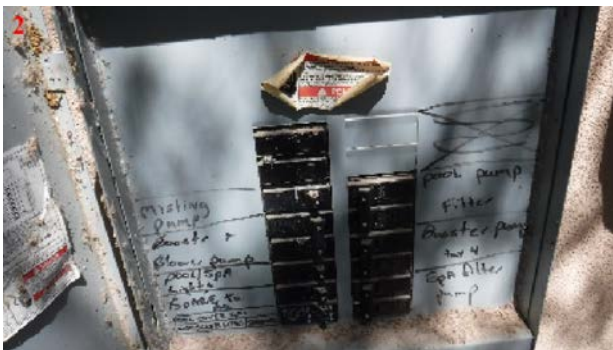
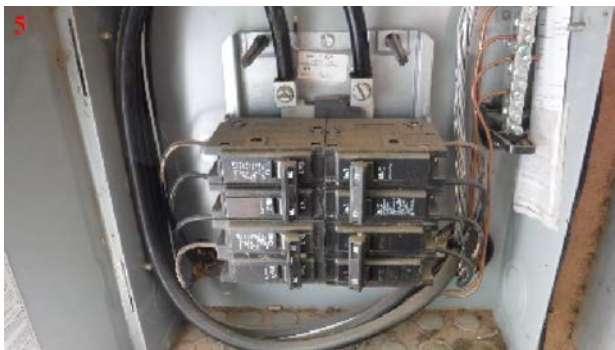
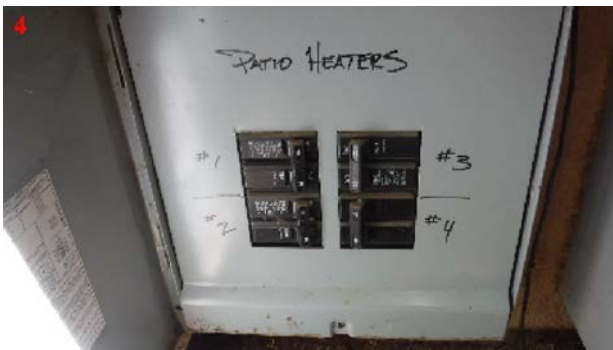
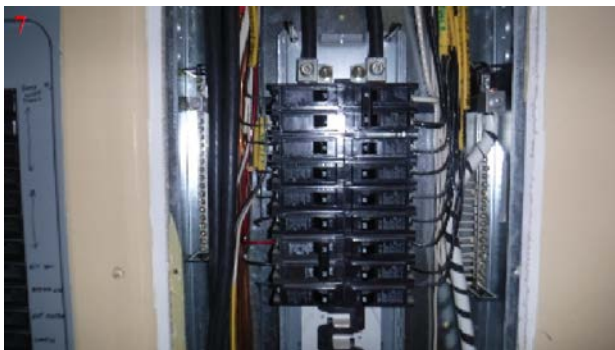
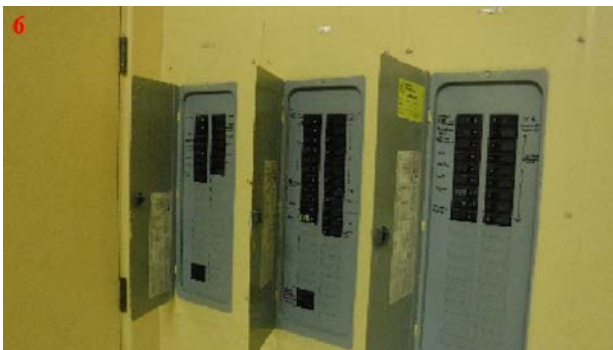
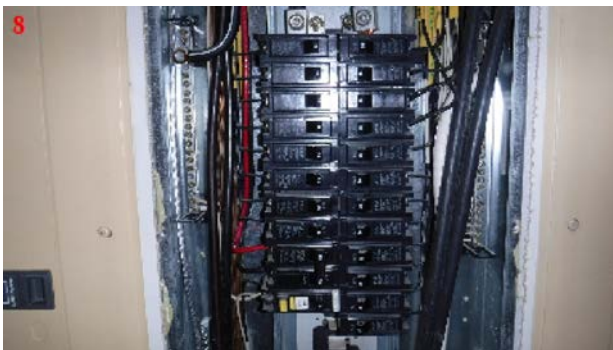
Sub Panel - Pool Equipment, Beside Main, Garage, Other

Other = North

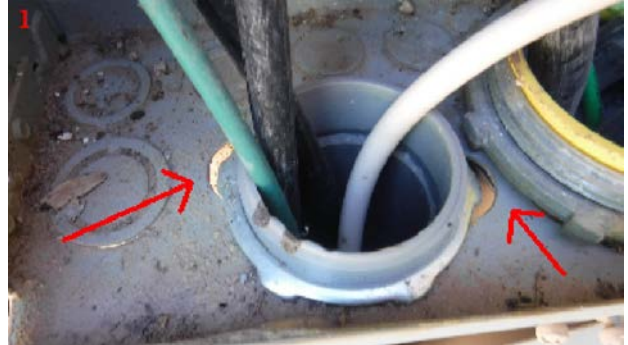
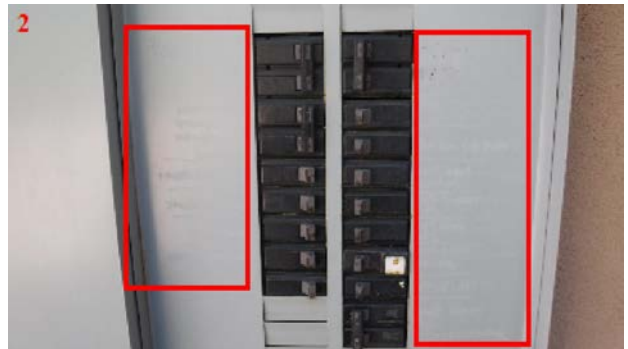
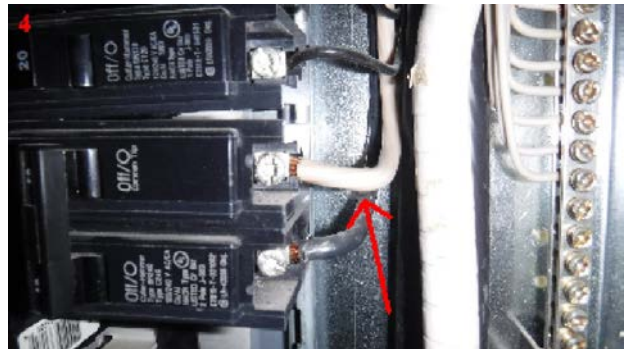
Safety Concern Electrical Faults - Sub Panel 1, Sub Panel 2, Other

Sub panel D - Gaps around bottom knock outs should be sealed to prevent pest intrusion.
Sub panel D - Most labels have faded and should be relabeled.
Sub panel B- Pointed screws were noted at panel cover and should be replaced with blunt screws.
Sub panel A and Sub panel C - White wires are noted on main breakers- these white wires are designated neutral wires- when attached to breakers they should be covered with black tape or colored black with magic marker. Not uncommon to see white wires on breakers but should be covered properly.

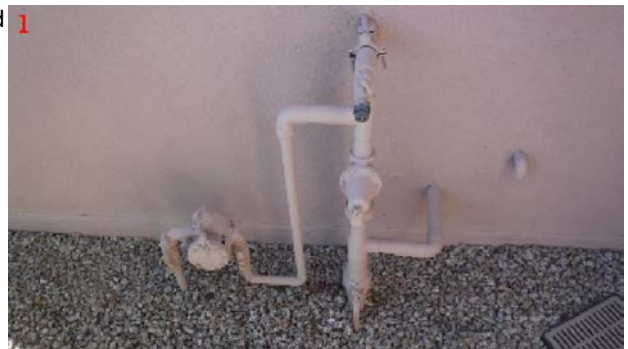
Satisfactory Main Water Shut Off - Exterior

Home inspectors do not turn main lines on and off- beyond standard due to potential for leaking. Main shut off valve is located on East side of home.

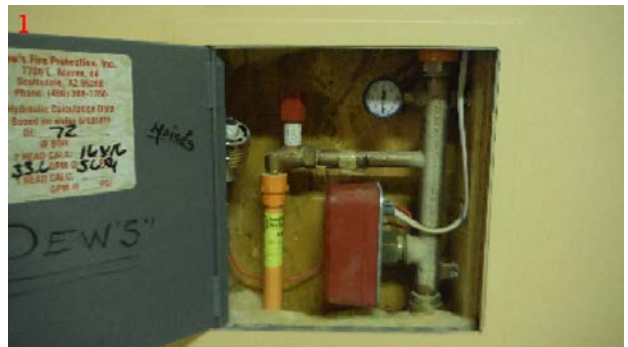
Satisfactory Interior Visible Water Pipes - Copper, Plastic

The building is served by copper potable water pipes (where visible - other piping types may exist). Copper stub outs noted under cabinet- limited visual. Most water distribution pipes were not visible due to wall, floor and ceiling coverings. Plumbing to sprinkler fire suppressant system is plastic.

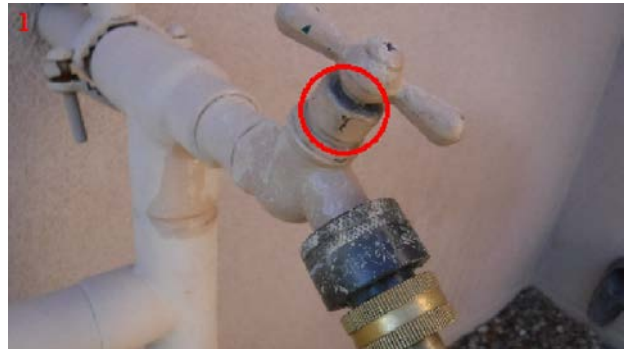
At least 5 hose bibs leaked at packing nut when water was run. Recommend repair. Example: East, West, etc...

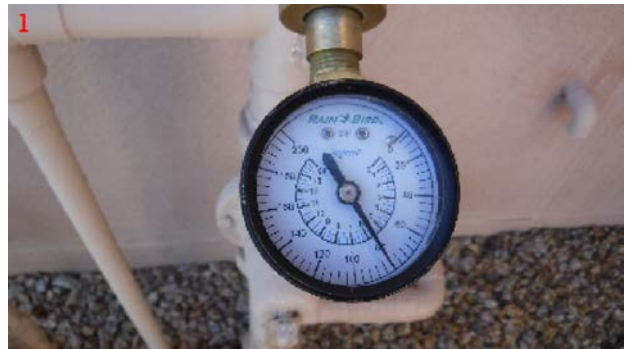
Satisfactory Water Pressure - Adequate

Water pressure at the hose bib at the front of the home was 80 psi. The standard range is 45-65 psi. Pressure reducer valve is installed.

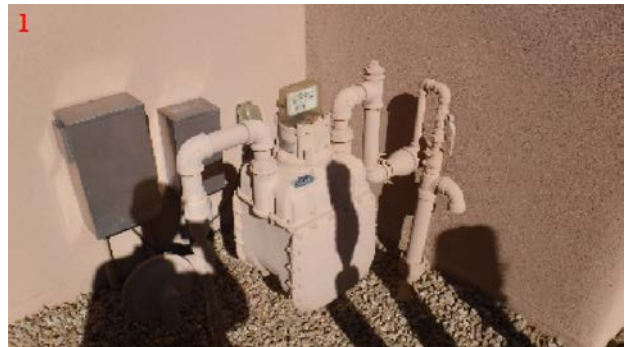
Satisfactory Main Gas Valve - Exterior

Gas shut off is located on East side of home. Property has a gas system and appliances, you must realize that our inspection for leaks is limited to the use of the inspector's sense of smell only. If you have any concerns contact the fuel supplier for additional system leak testing (not part of this inspection) prior to closing escrow.

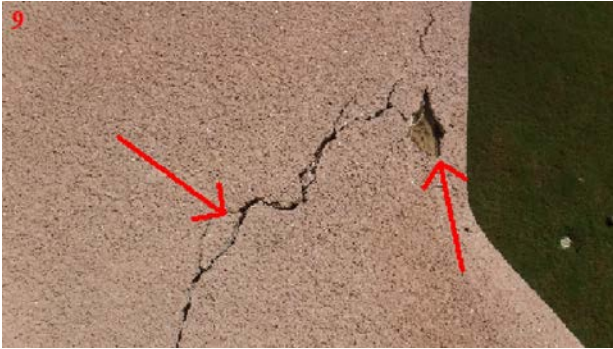
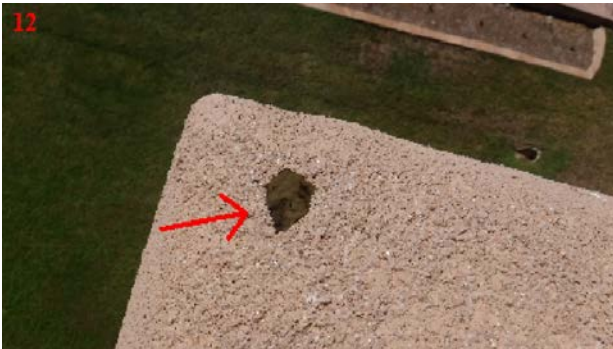
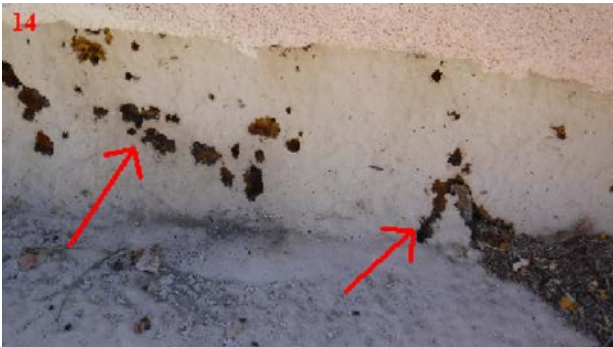
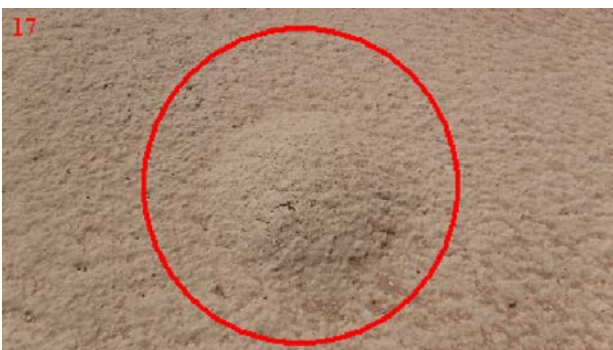
Service/Repair Roof Covering - Spanish Clay Tile , Foam

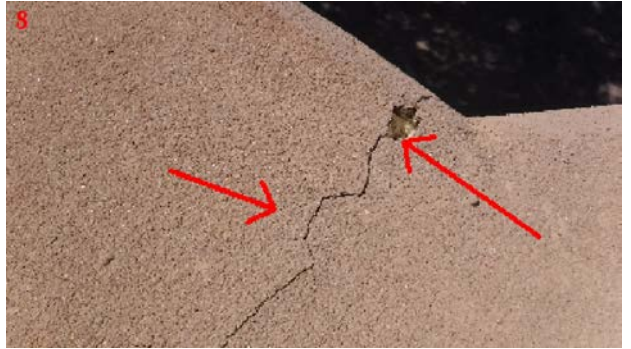
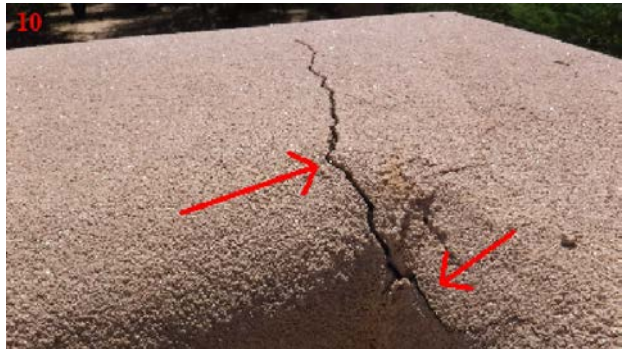
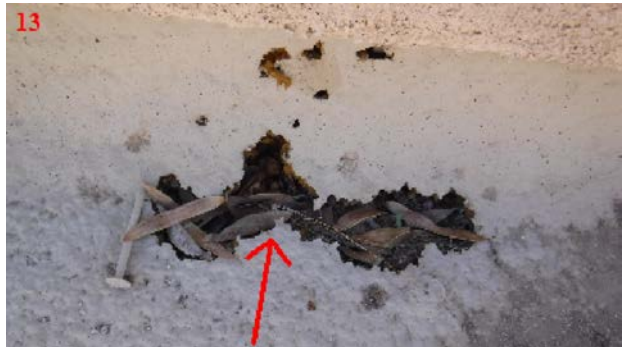
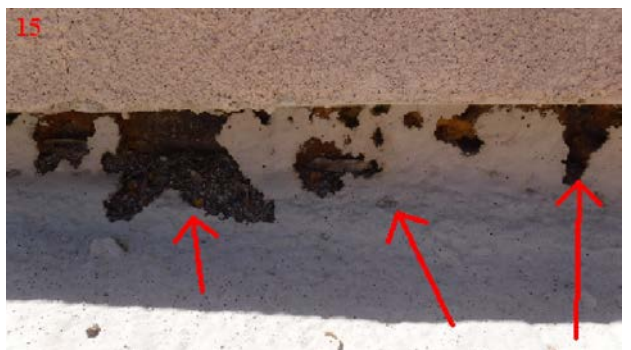
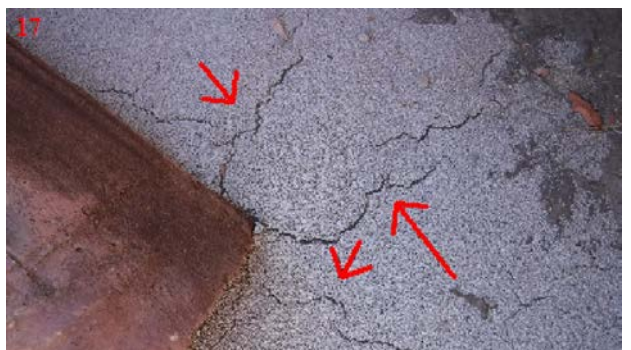
Few cracked or smashed clay tiles were noted, at least 6.

There is a lot of debris on the roof which should be cleaned off to prevent roof leaks.

Foam roofing has few blisters 15 or so noted- from 1 inch to 10 inches in size. Industry standard is any blister above 2 inches should be repaired. Did not see any with holes in them.

Many areas around flat foam roof perimeter have deteriorated or birds have pecked through. These areas should be repaired to prevent moisture intrusion.

Few areas of parapet wall were cracked beyond typical and had few holes which should be sealed and repaired.

Recommend further evaluation and repair by qualified roofing contractor prior to close.

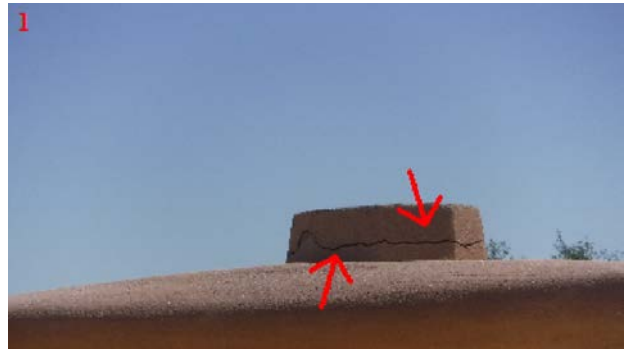
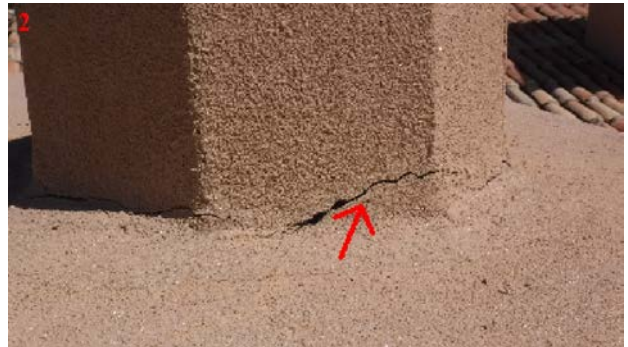
Service/Repair Chimney 1 Type - Stucco

All chimneys have large stucco cracks, approximately width of a quarter in size, where flue meets chimney cap. Recommend repair to prevent moisture intrusion.

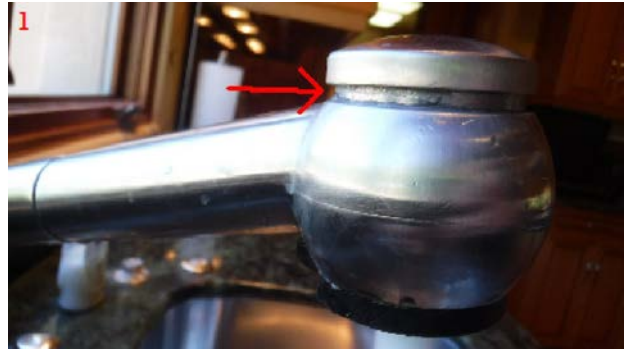
Service/Repair Kitchen Sink 3rd Faucet - Sprayer

Kitchen main faucet, leak noted when button is depressed.
Recommend repair.

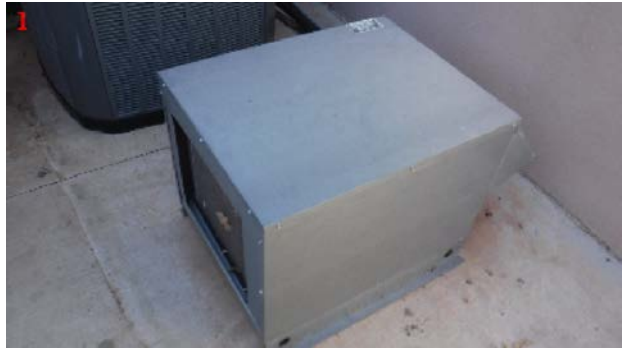
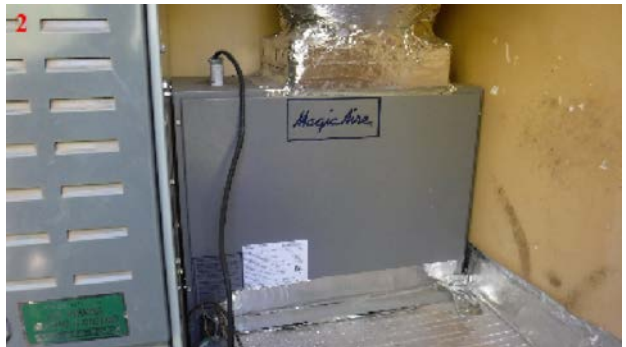
The optimum temperature for wine cellars storing a variety of wines is generally agreed upon as being between 52F (11C) and 59F (15C). Temperatures between 40F (4C) and 65F (18C) are considered acceptable. The temperature in the wine cellar at the time of the inspection was 53 degrees .

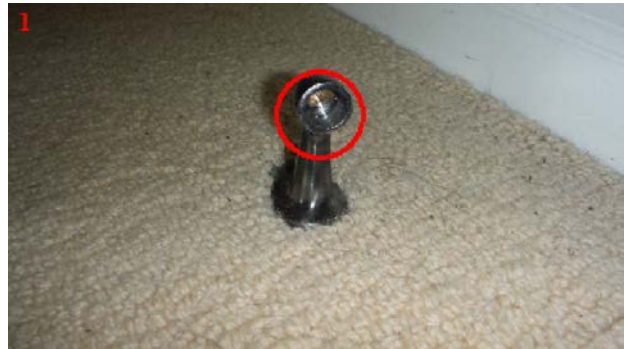
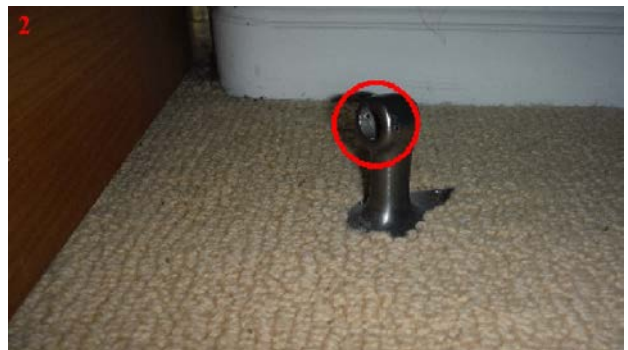
Service/Repair Interior Doors - Needs Repair

Damaged or missing door stops noted. Can cause door knobs to damage drywall and damage to doors. Examples: Rubber stoppers missing - Master entry and patio doors, Foyer Main Entry doors, Coat closet, etc...

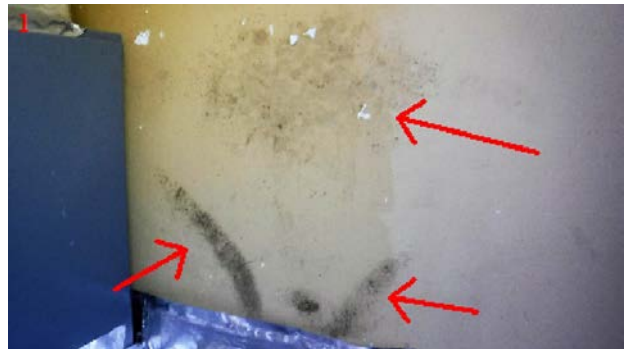
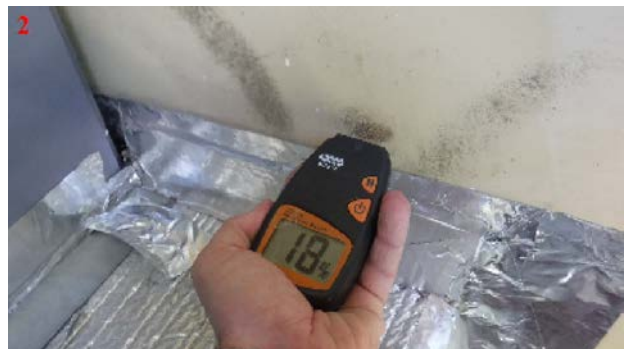
Service/Repair Interior Walls - Needs Repair

NW mechanical room, potential mold like substance on the walls visible at the time of the inspection appeared to be the result of moisture. The moisture meter showed elevated moisture levels in the affected areas at the time of the inspection. The Inspector recommends further evaluation and repair qualified contractor prior to close.

Trim is warped in this area also.

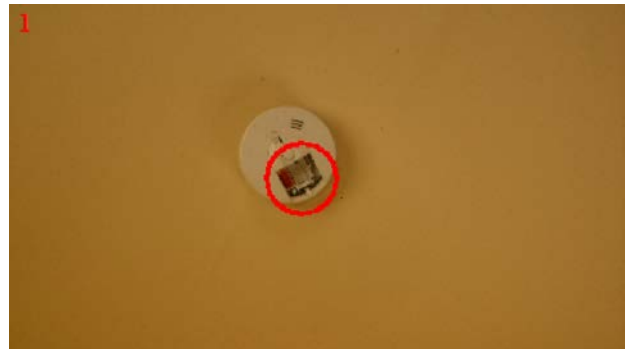
Safety Concern Smoke Detectors - Present

Several smoke detectors on South side of home are missing batteries. Recommend batteries be installed
Smoke detectors should be checked on the day home is occupied.

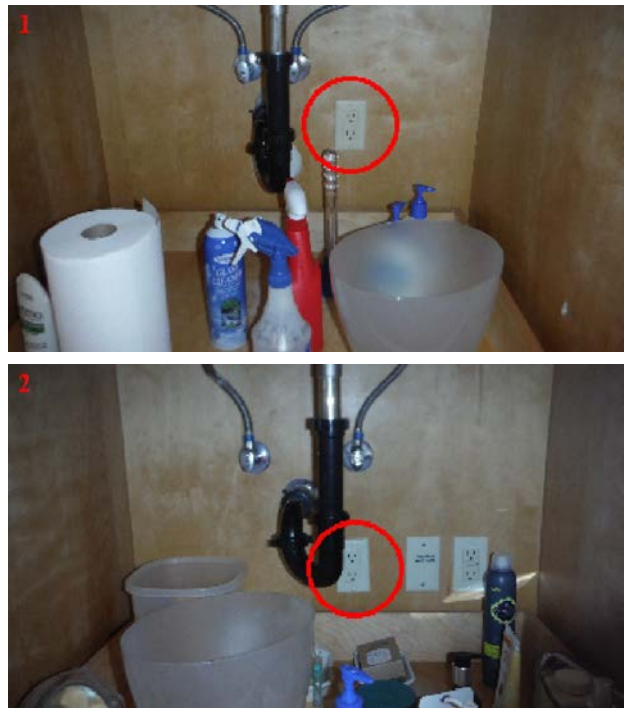
Service/Repair Bathroom Outlets - GFCI, Grounded

Outlets under bathroom sinks were not energized at time of inspection.

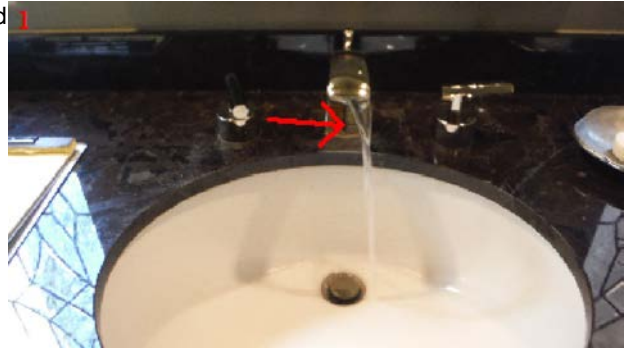
Service/Repair Bathroom Sink Faucets - Needs Repair

NE office bathroom hot water has restricted flow at vanity sink. Cold water flow as acceptable. Recommend repair.

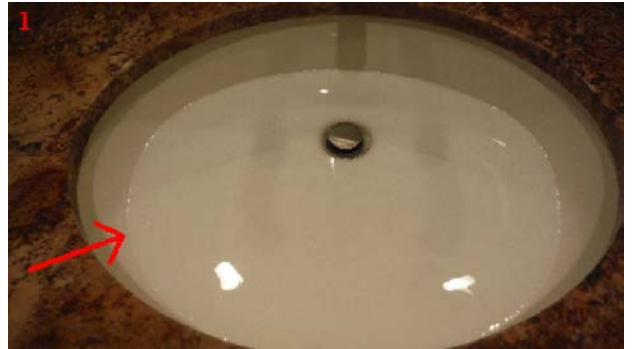
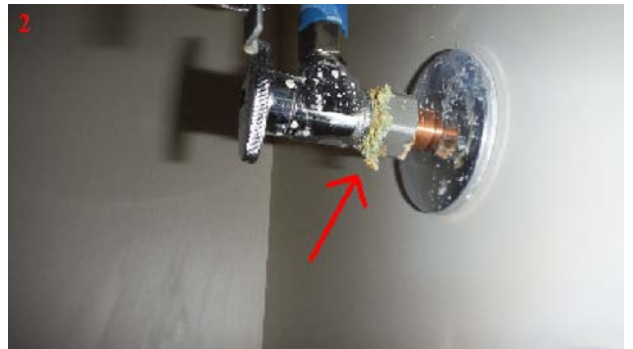
Service/Repair Bathroom Sink Drain and Trap - Needs Repair

SE bathroom sink was slow to drain. Recommend cleaning.
SW bathroom, corrosion was noted at the hot water shut off valve.
Not leaking at time of inspection.

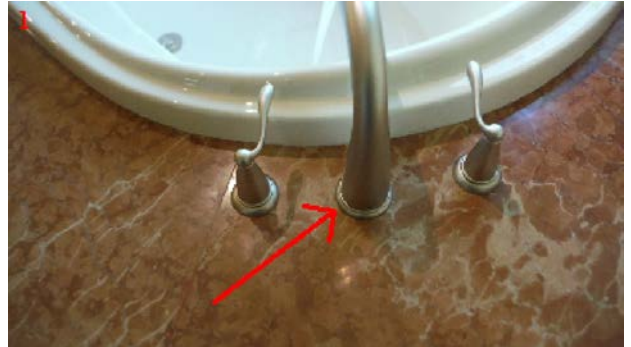
Service/Repair Bathtub Faucets - Needs Repair

Master bathroom tub filler/spout is loose.

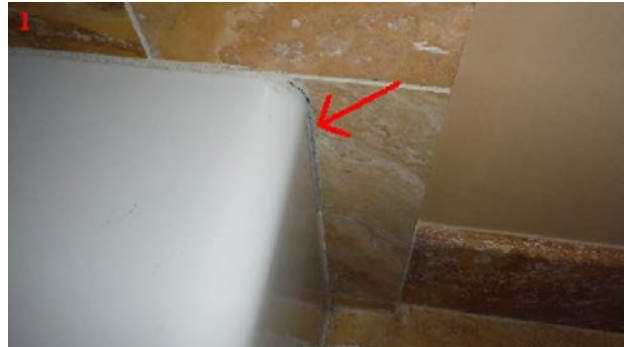
Service/Repair Seal Around Bathtub - Needs Repair

SE bathroom tub, cracked grout noted along right side. Recommend improving seal.

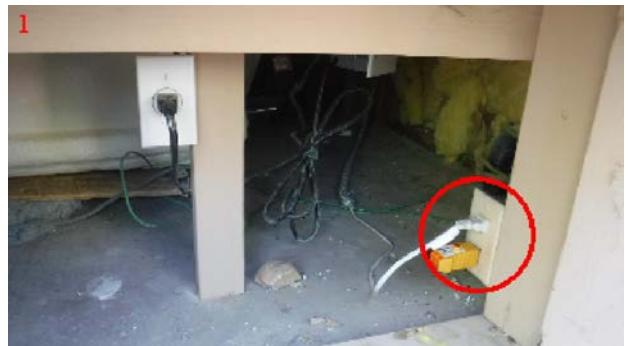
There are 2 outlets under the master bathroom spa tub 1 is GFCI protected as required, 1 outlet is not GFCI protected. Would expect both outlets to be GFCI protected, recommend repair.

Unable to determine if spa pump is bonded due to limited visibility.

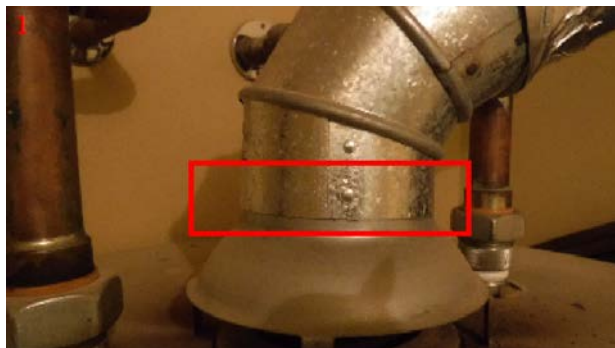
Safety Concern Water Heater Flues / Chimneys - Needs Attention

Garage vent pipe not properly fastened with three screws or taped at each of the joints. Example: flue to divertor connection

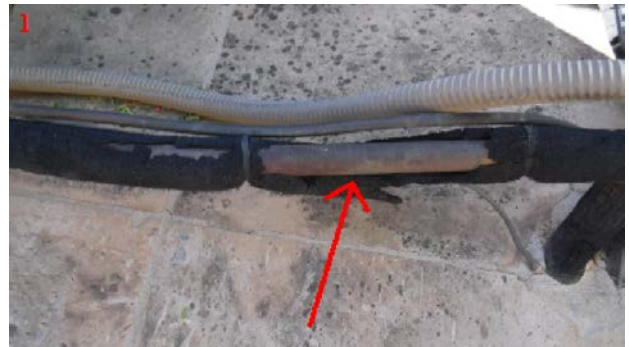
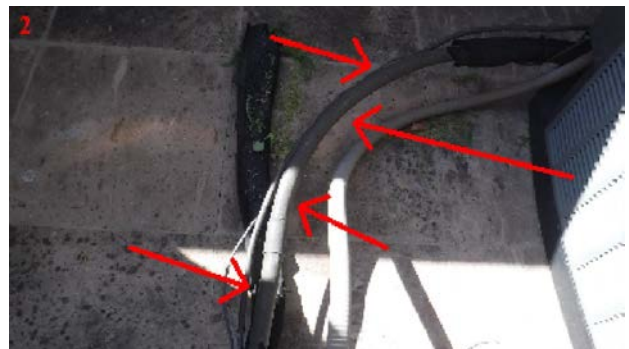
Cooling Lines - Insulation Missing

Insulation is missing on cooling line at South condensing units- insulation should be repaired/replaced.

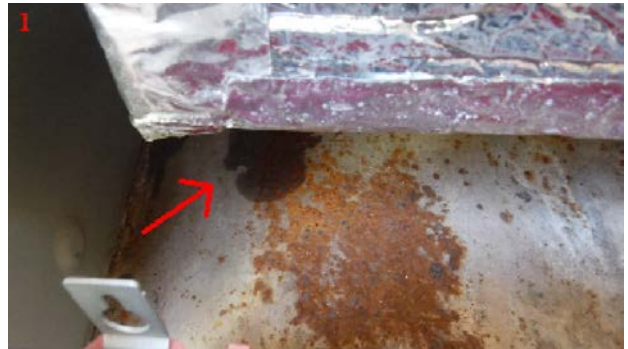
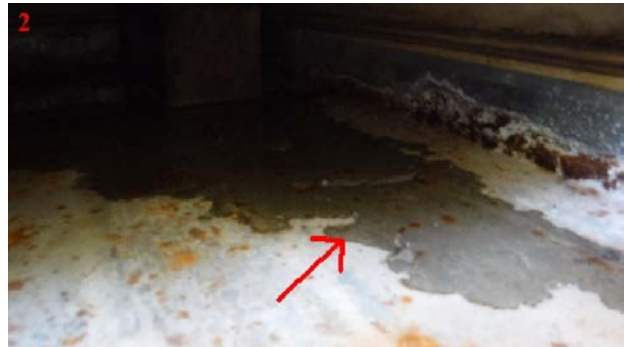
Service/Repair Condensate Drain - Plastic

Evidence of condensate and rusting along the North mechanical room pedestal indicates that the primary drain is clogged, and an HVAC contractor should clean out condensate drains. North condensate drain discharges at soil level. This could cause the drain to back up. Recommend there be at least 1inch gap between drain and soil.

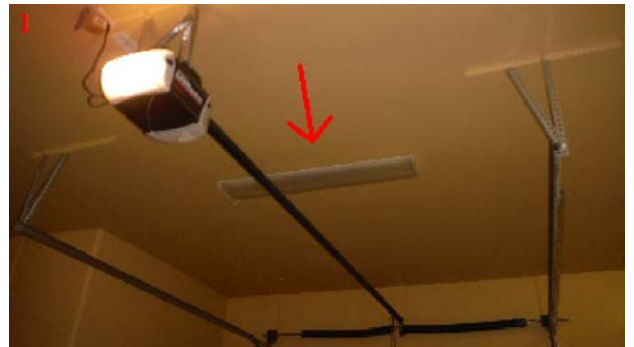
Service/Repair Garage Electrical System - Switches, GFCI, Overhead, Lighting

Garage florescent light above garage #2 did not respond to available controls. Could be failed bulb or ballast.

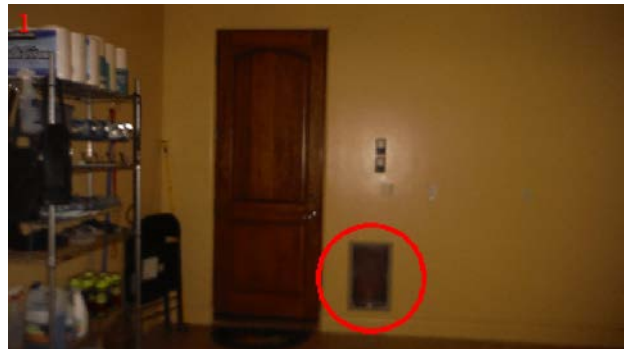
Safety Concern **Garage Separation Walls - Needs Repair**

Doggie door installed along garage separation wall is not fire rated-
recommend removing doggie door and replacing with 5/8 inch
drywall for proper fire rating.

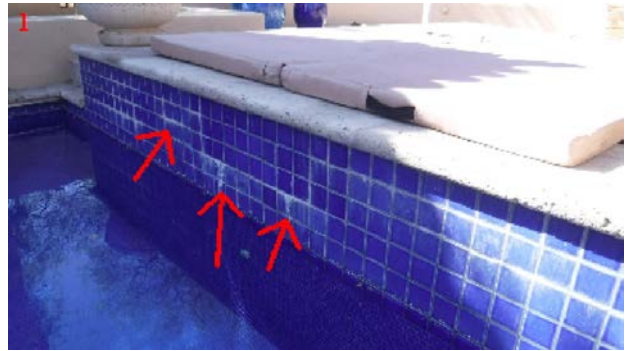
The pool had a electrically-operated mechanical cover designed to cover and uncover the pool with a switch. Tested operational.

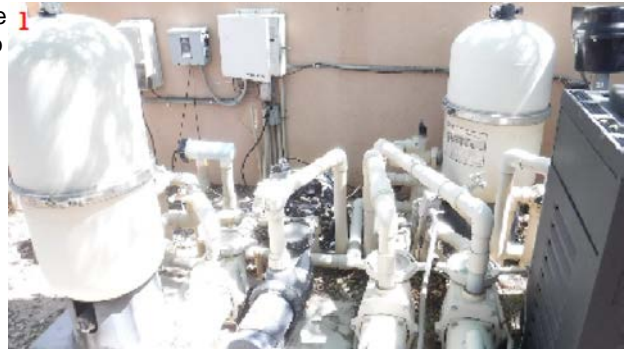
Service/Repair Equipment - D E

Pop ups are not operating properly- Only 4 pop ups operated at time of inspection- pressure should fluctuate as this system is cycling- no change at entire time at equipment. Recommend further evaluation and repair by qualified pool professional.

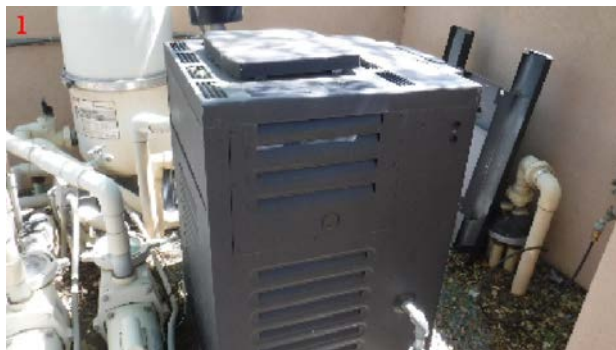
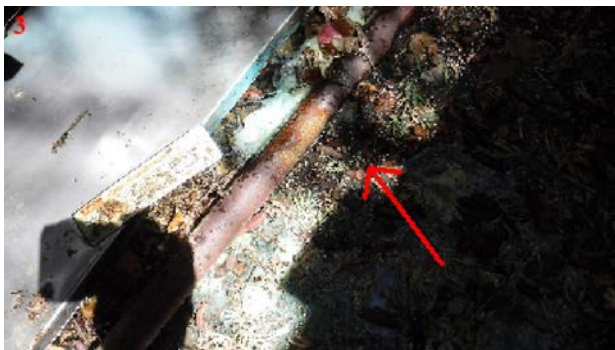
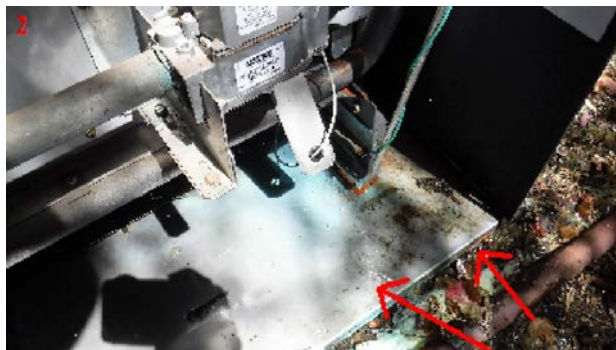
The pool heating system appeared to be inoperable at the time of the inspection. LED displayed "Ignition failure" when tested. Excessive water was leaking in heater cabinet at time of inspection. No evidence of gas shut off within 6 ft of gas fired heater. Recommend shut off valve be installed. Gas line to gas fired heater is running along soil and rusting. Gas line should be wrapped if in soil or elevated above soil to avoid rusting. Recommend repairs. The Inspector recommends that the entire heating system be evaluated and any necessary repairs be made by a qualified contractor. If unit would need to be replaced the cost may exceed \$2000.

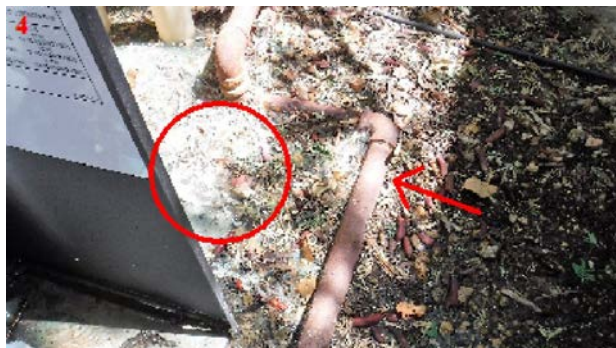
Heaters - Gas

The pool heating system appeared to be inoperable at the time of the inspection. LED displayed "Ignition failure" when tested.

Excessive water was leaking in heater cabinet at time of inspection.

No evidence of gas shut off within 6 ft of gas fired heater. Recommend shut off valve be installed.

Gas line to gas fired heater is running along soil and rusting. Gas line should be wrapped if in soil or elevated above soil to avoid rusting. Recommend repairs.

The Inspector recommends that the entire heating system be evaluated and any necessary repairs be made by a qualified contractor.

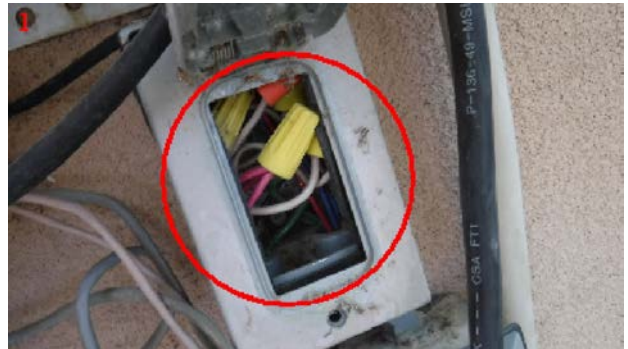
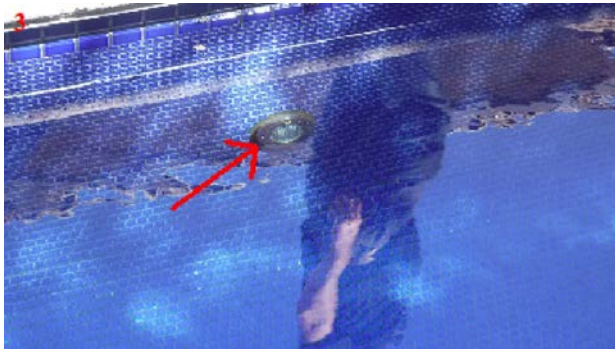
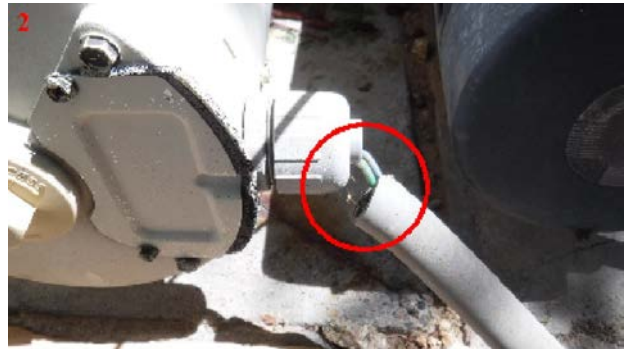
Safety Concern **Electrical - Generally Good Condition**

Junction box with a switch cover in the pool equipment area has exposed wiring noted and proper cover should be installed to prevent injury.

Armor cable conduit at pump is loose, wiring is exposed.

1 pool light did not respond to available controls. Recommend repair.

Recommend repair.

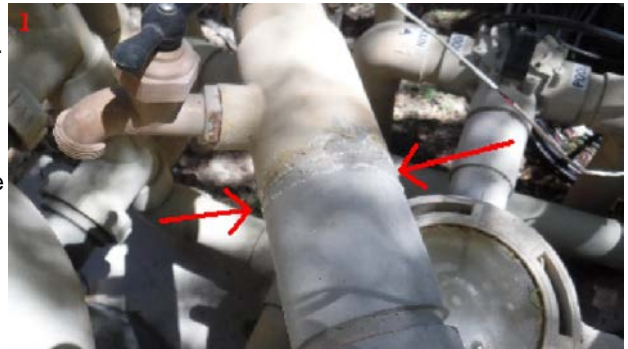
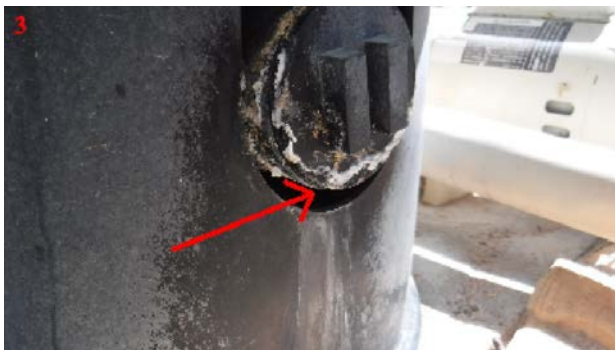
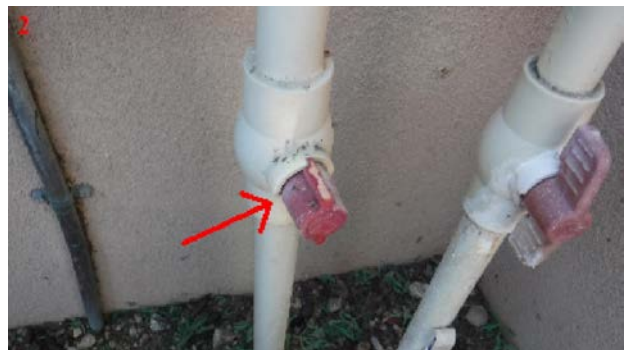
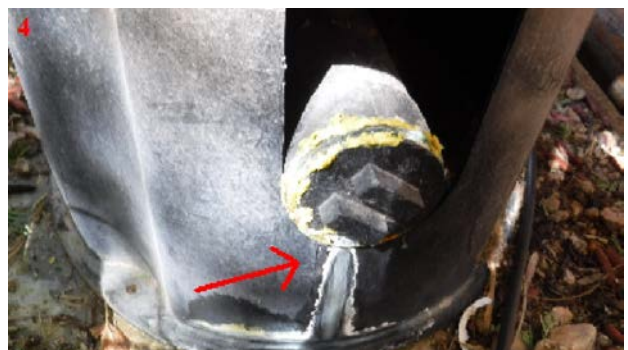
Service/Repair Pipes & Valves - Needs Repair

Leaks were observed at the bottom of both filters at the drain cover.

A leak was visable along the PVC plumbing and should be repaired.

A leak was noted along the port valve assembly and should be repaired.

A broken ball valve handle was noted.

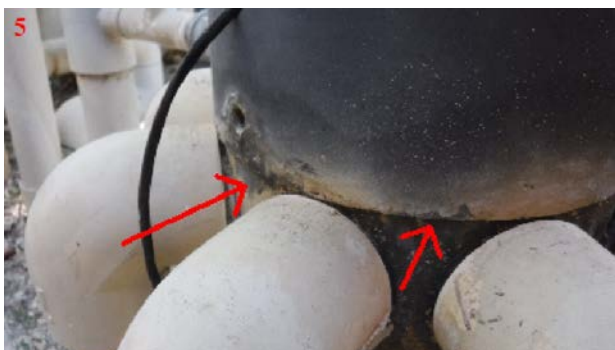
Leaks were observed at the bottom of both filters at the drain cover. A leak was visible along the PVC plumbing and should be repaired. A leak was noted along the port valve assembly and should be repaired.

A broken ball valve handle was noted.

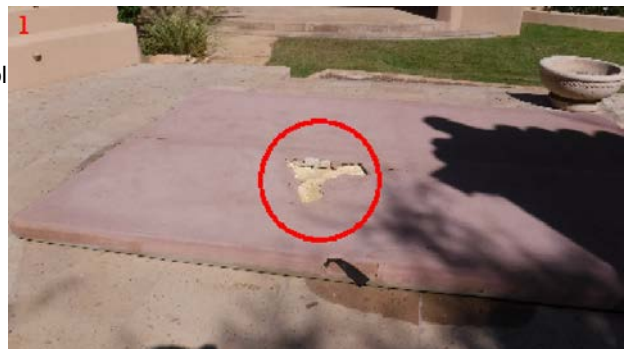
Service/Repair Spa - Present

Spa cover was damaged.
